MOULD IN NEW BUILDINGS

The following images are from a range of brand new and less than two year old homes. The issues are caused by the natural drying out process of a new home followed by additional moisture & humidity created by occupants.

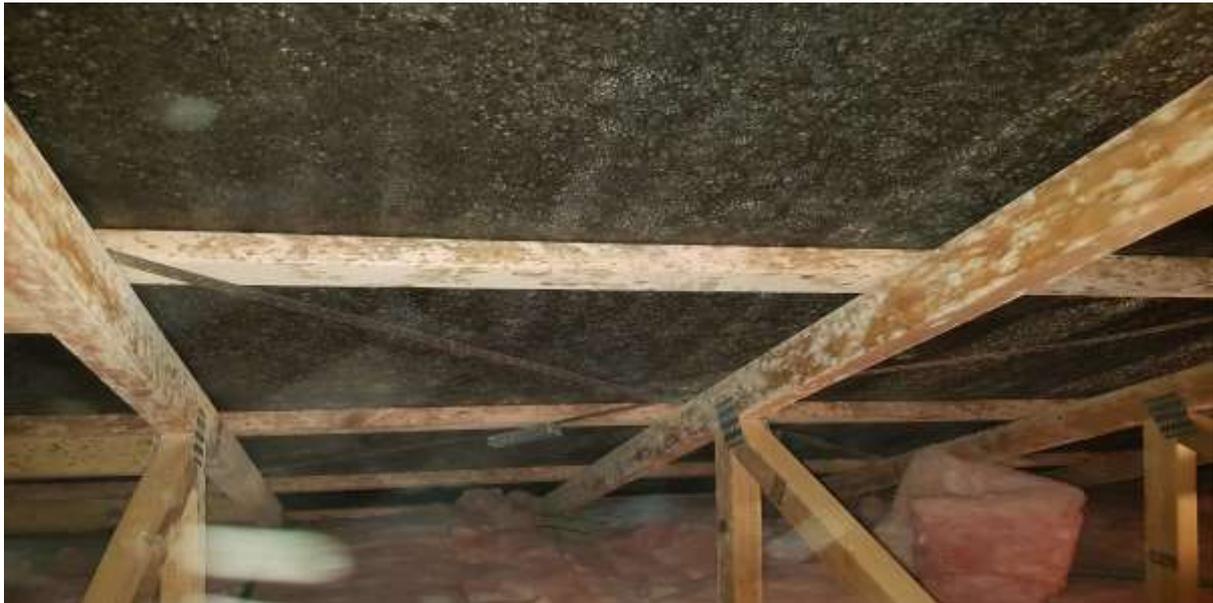
The specifications to these homes are similar but the common denominator is that these large volume housing groups have opted *not* to ventilate the roof void.

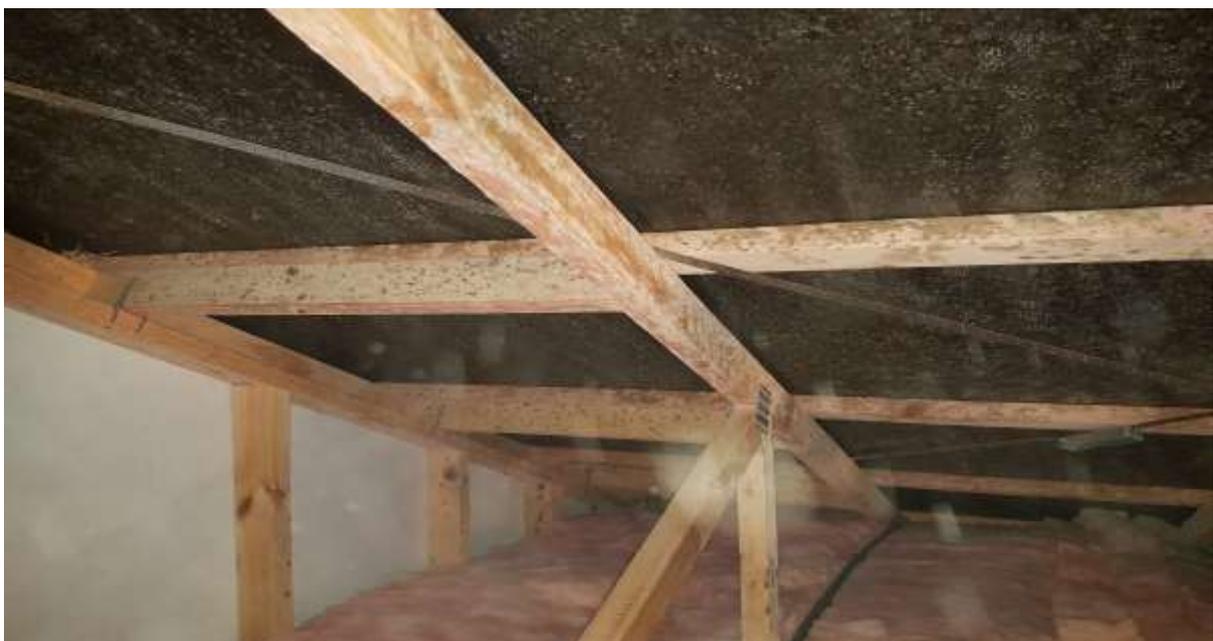
Natural drying out process - The concrete slab on an average sized new home will contain around 1000 litres of water which will take around 4-6 months to completely dry out. Add to that 250 litres of paint along with the wet trades (Tiling and Gib-Stopping) and you have a mass of accumulated moisture/humidity. This will rise into the unventilated roof void where it cannot escape resulting in the images shown.

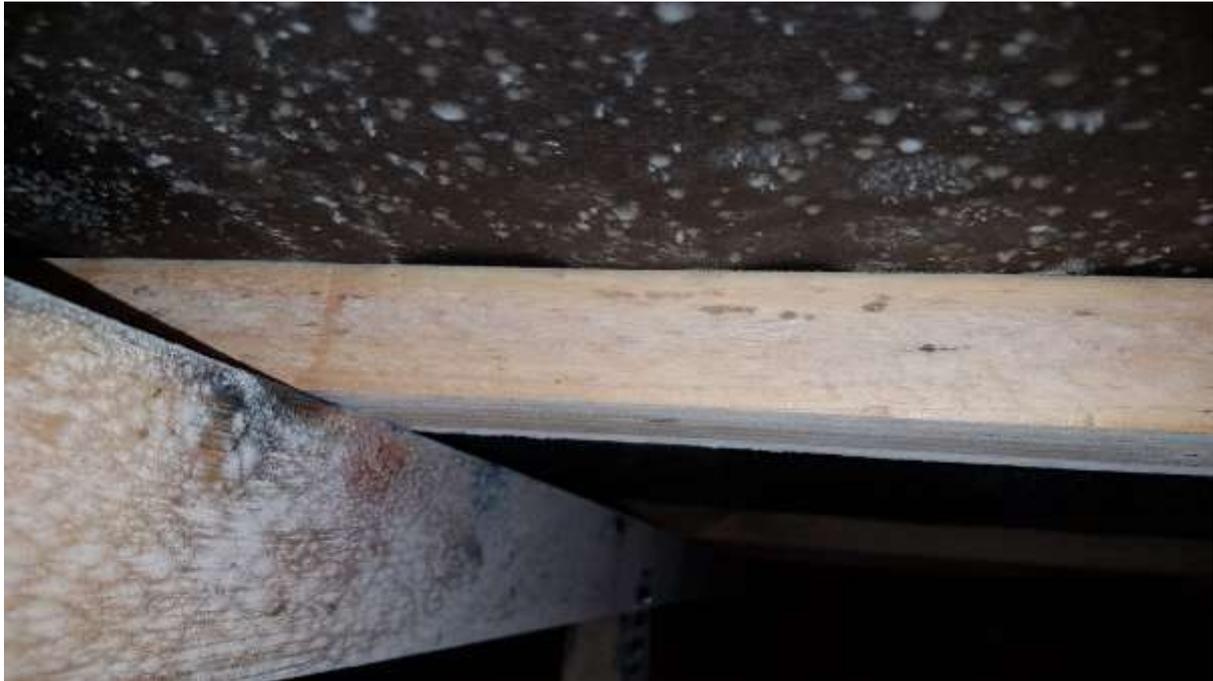
The image below was taken on a brand new home prior to the new home owners moving in. Consequently, the moisture levels are created solely by the drying out process without the aid of additional occupation-generated moisture.

This was a winter build which would have increased the likelihood of additional moisture from saturated frames prior to being wrapped. Again the moisture has accumulated in the unventilated roof void and become trapped when the ceiling lining and insulation is applied.

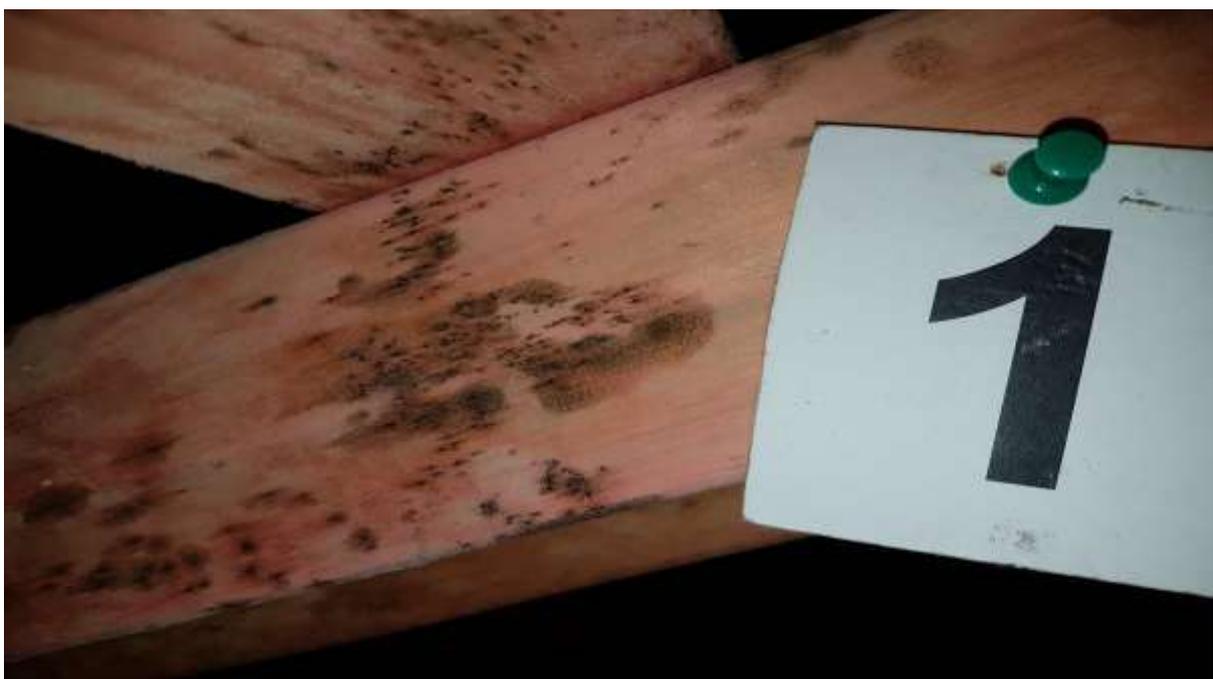
Mould Species - The common mould species found in these situations are Penicillium and/or Cladosporium. Both species are non-toxic but still high in sporulation and capable of triggering respiratory related allergens.

Cladosporium will establish on timber and membranes with a moisture reading of 15-20%.

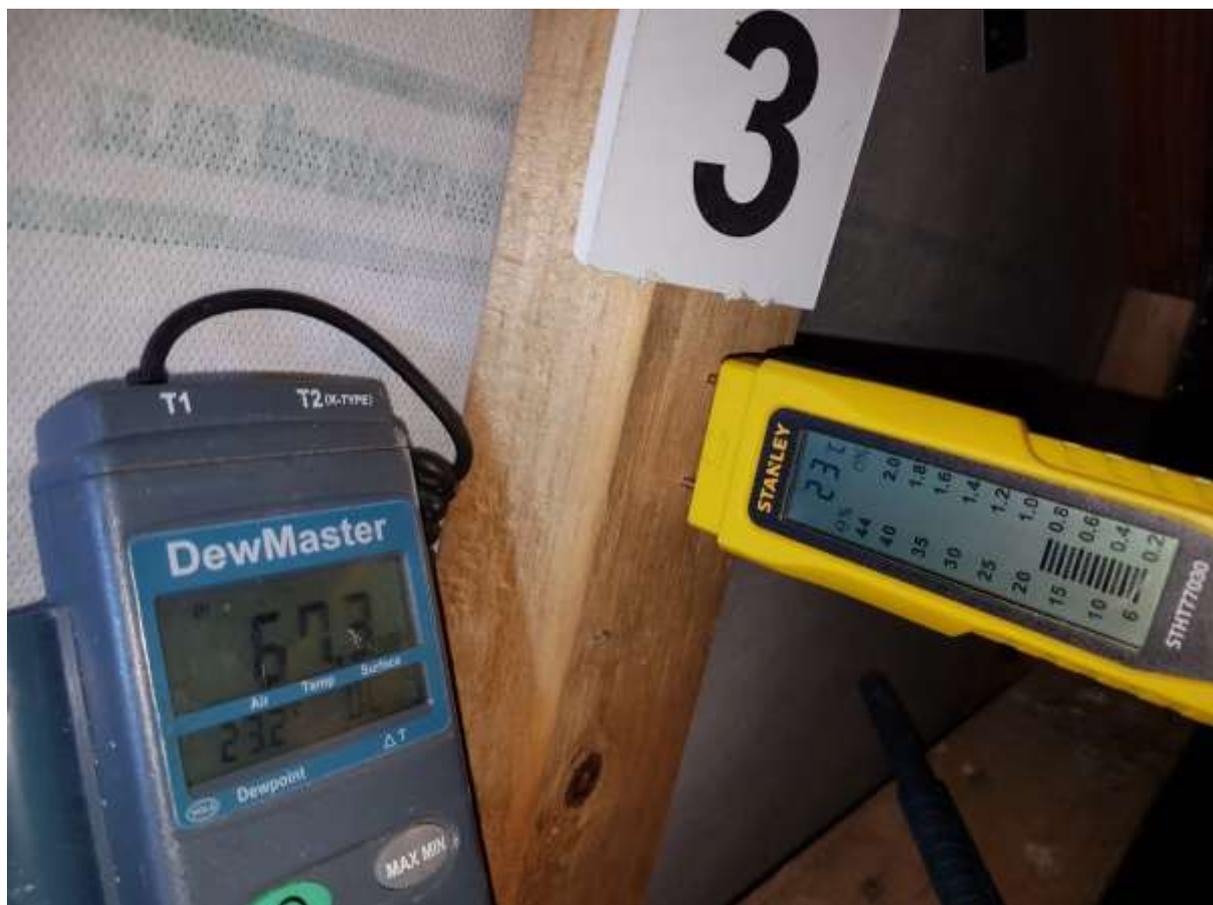
All of these case studies were moisture & humidity tested over several months confirming that the trapped moisture could not be naturally reduced below 15% without the further aid of passive roof ventilation.

This case study resulted in total chemical decontamination of the roof void, installation of retrospective roof ventilation and further testing to resolve the issue.

It would have cost less than half of this amount to ventilate the roof during the build process.

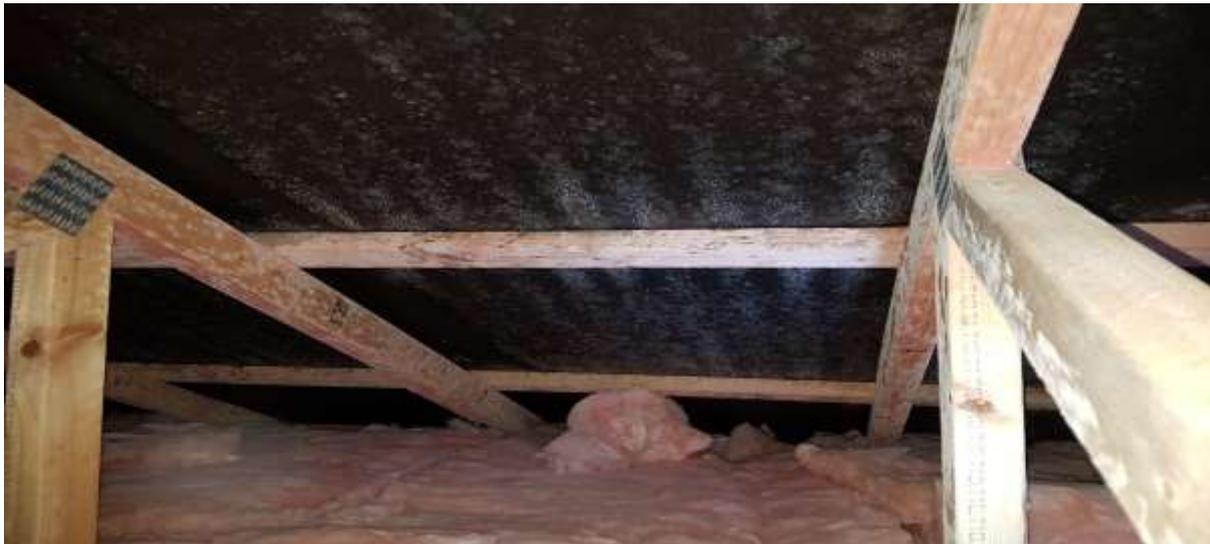
The image below illustrates a two year old home with abundant and active mould growth. This was assessed during the summer months when environmental moisture levels are at a minimum hence indicating that continued occupational generated moisture levels are not capable of ever being reduced below 15% without the additional aid of roof ventilation.
