ASSESSOR REPORT

Client name:	Tel:
Site address:	Email:
Date: 11/10/17	Job Ref: TD/138

This was a non-invasive inspection undertaken on 10/10/17. The objective was to assess the regrowth of mould in the roof void. The mould on the roofing underlay and timber roof structure was chemically decontaminated on 28/09/17 as per photos provided at the time.

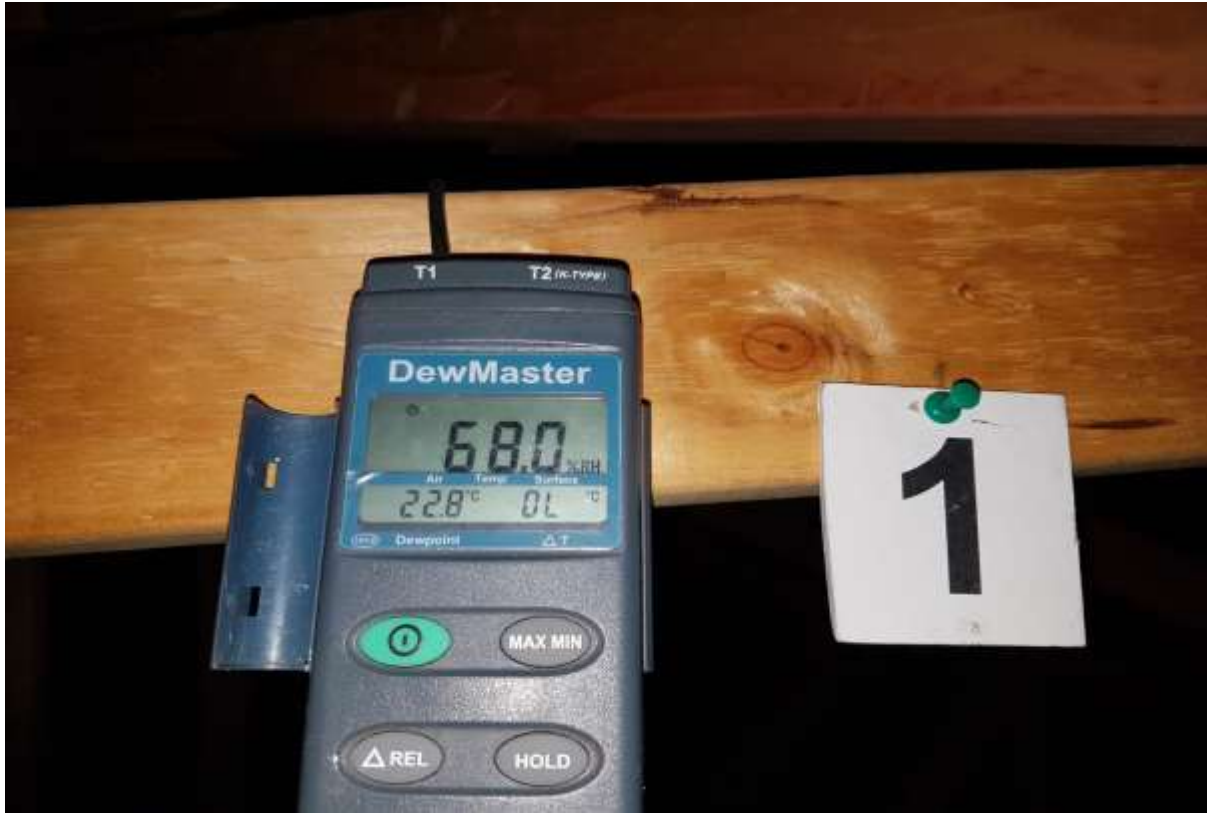
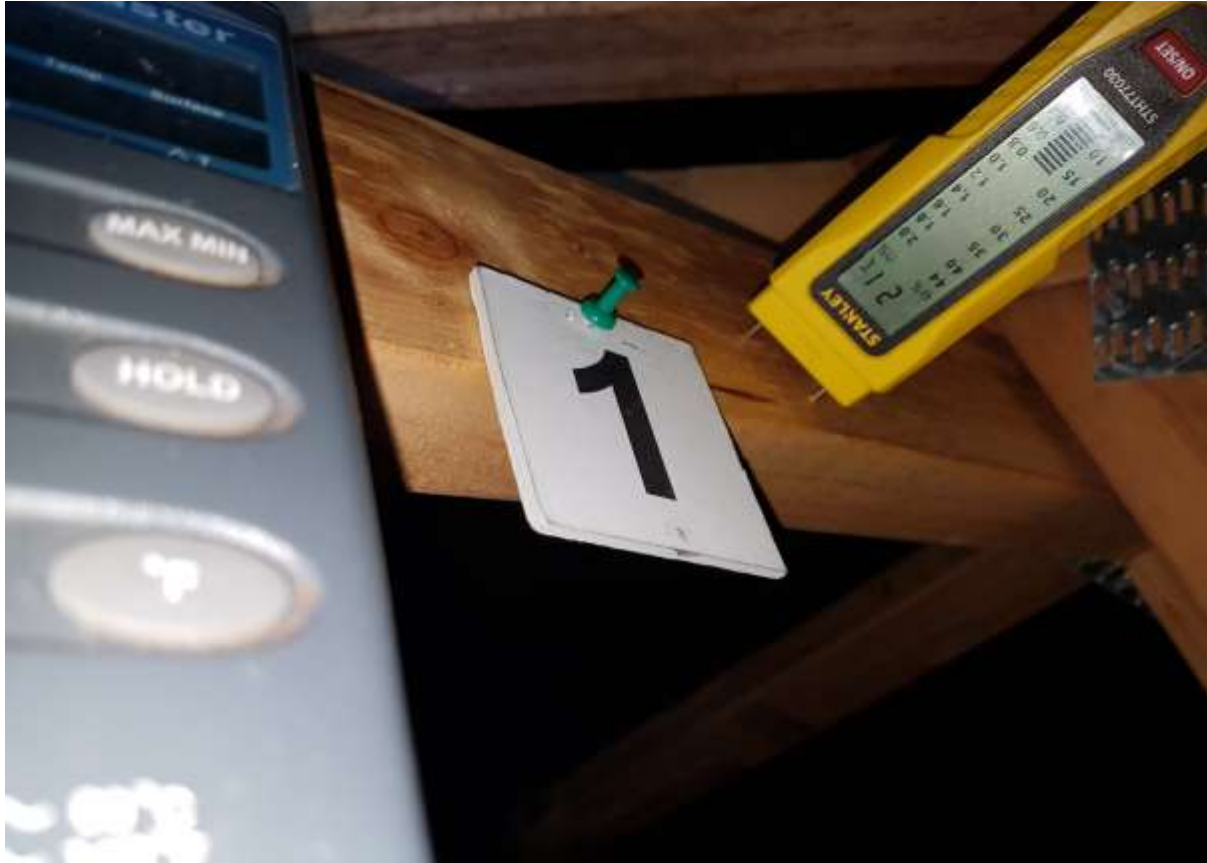
1) Highest point of the roof – Temperature: 22.8°C – RH: 68% - Moisture content 17%

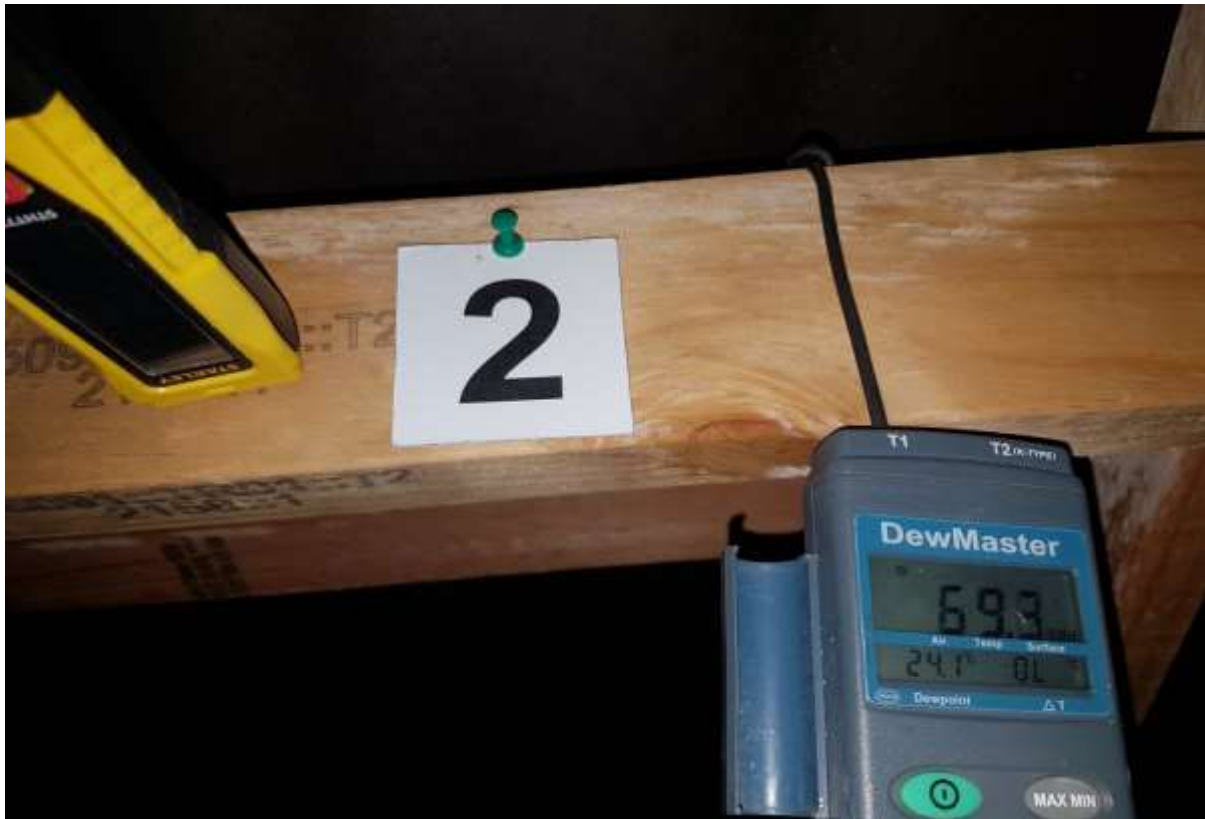
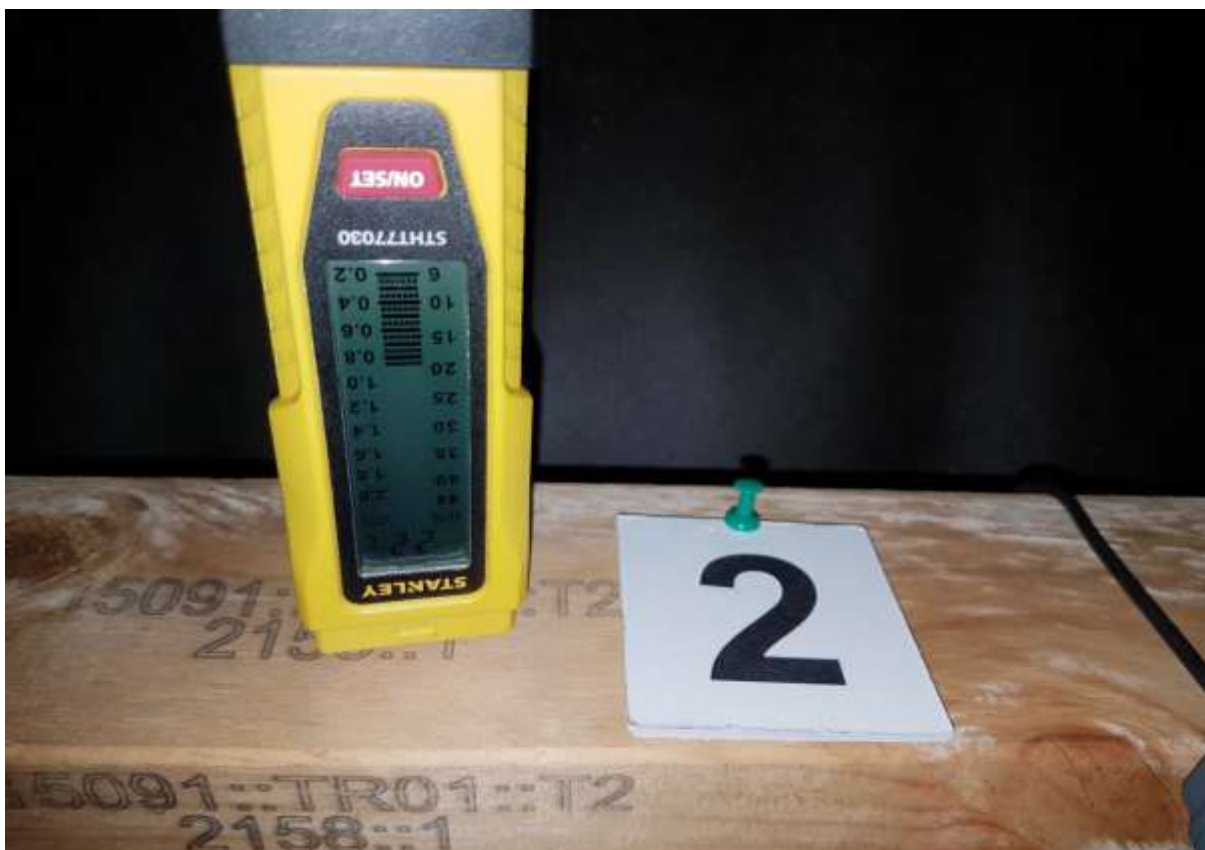
2) Over dry rooms – Temperature: 24.1°C – RH: 69.3% - Moisture content 19%

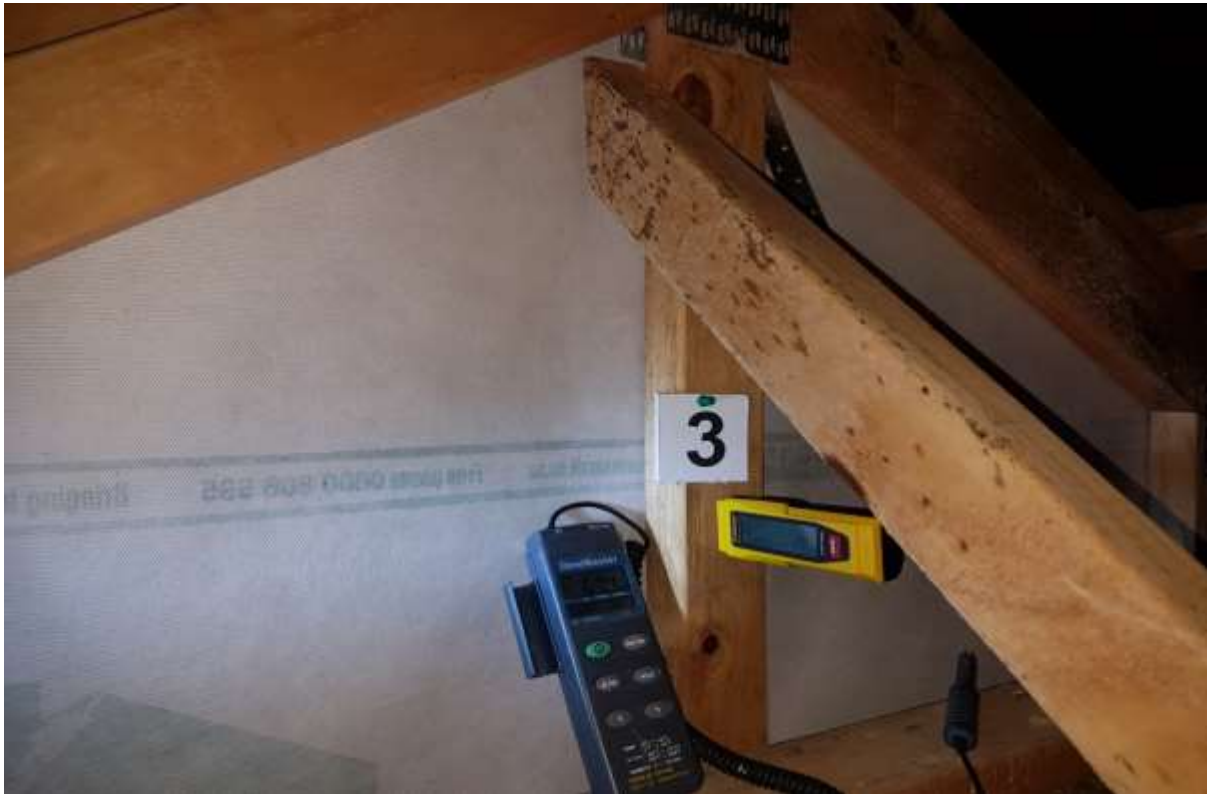
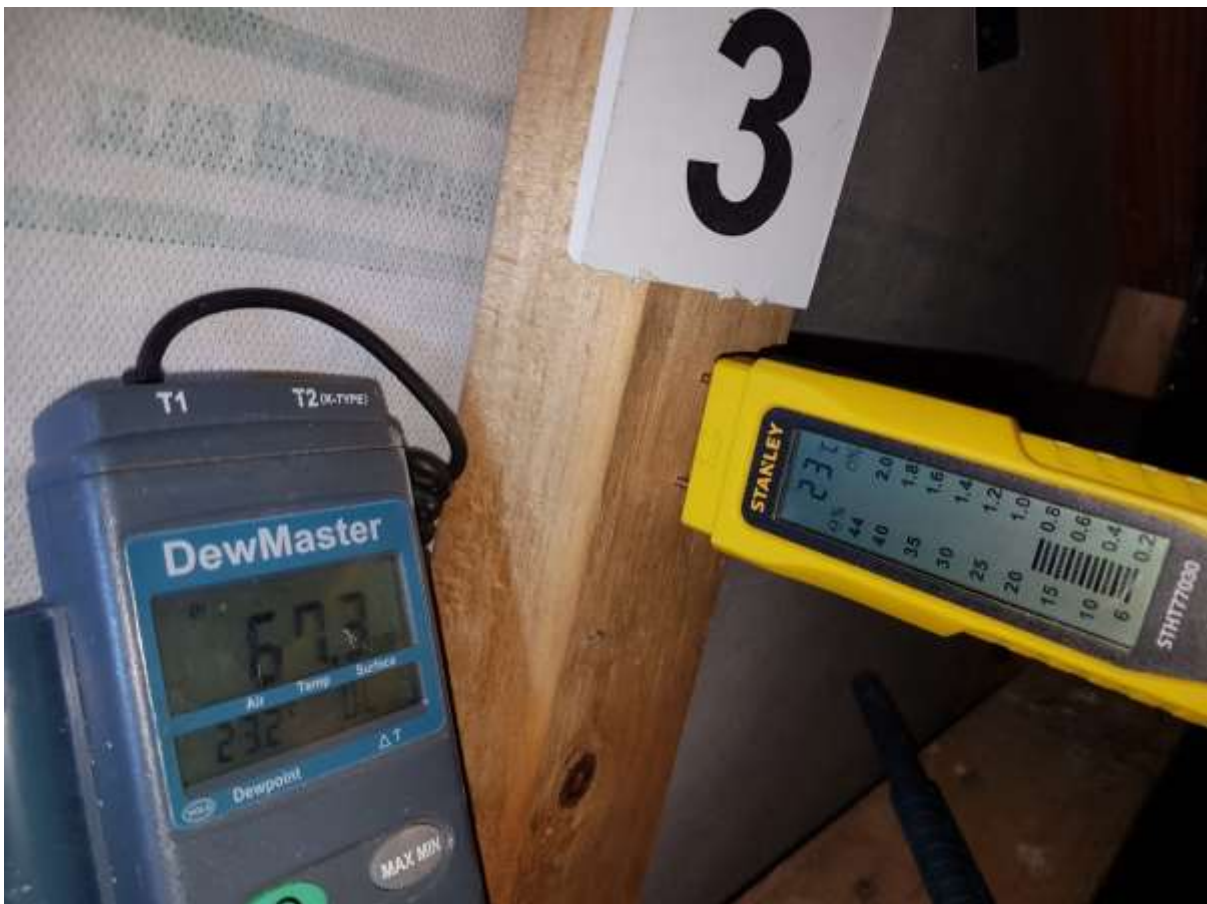
3) Over Garage – Temperature: 23.2°C – RH: 67.3% - Moisture content 19%

It appears that the timbers have now dried out to a moisture reading of below 20%. However, as stated in the Biodet Laboratory Report, Cladosporium being one of the two identified mould species along with Penicillium will establish on timber with a moisture reading of 15-20% which explains the rapid regrowth.

Conclusion - The RH readings average 68% which is high and the drying out process will be greatly prohibited due to the lack of airflow in the roof void. The home was completed at the end of September so the mould growth and high RH will have been instigated by the natural drying out process of the building. A typical concrete slab can contain 1000 litres of water which can take 4-6 months to dry out. Approximately 250 litres of paint would have been used on this property along with moisture generated from the Gib stopping. This was also a winter construction so it could be presumed that at some point the frames would have been exposed to wet weather. Once enclosed, this moisture will rise into the roof void and become trapped in a weathertight and unventilated roof.

Solution – Installing passive roof ventilation at house design stage is very simple but not so easy retrospectively. Two options could be suggested for rectification of this particular weathertight roof:

- 1) Soffit Vents installed around the perimeter of the property accompanied by ridge ventilation to draw the warm air from the roof via negative pressure. (www.vent.nz)
- 2) Gable vents installed to 4 gable walls. This will provide cross ventilation at high roof level covering a large area of the roof but not all.

Both methods will be uncalculated but will provide air release and permanently reduce the temperature and humidity in the roof void. This in turn will eliminate the mould problem.

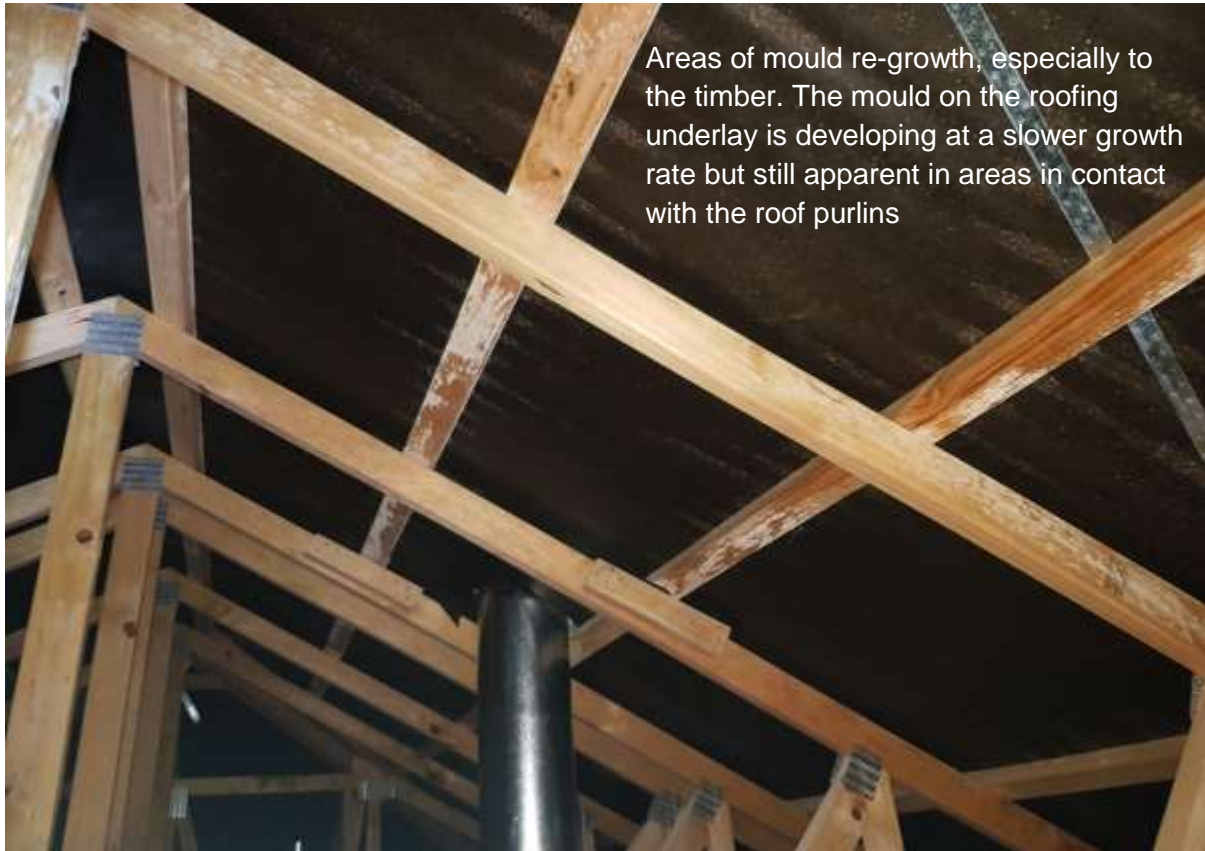
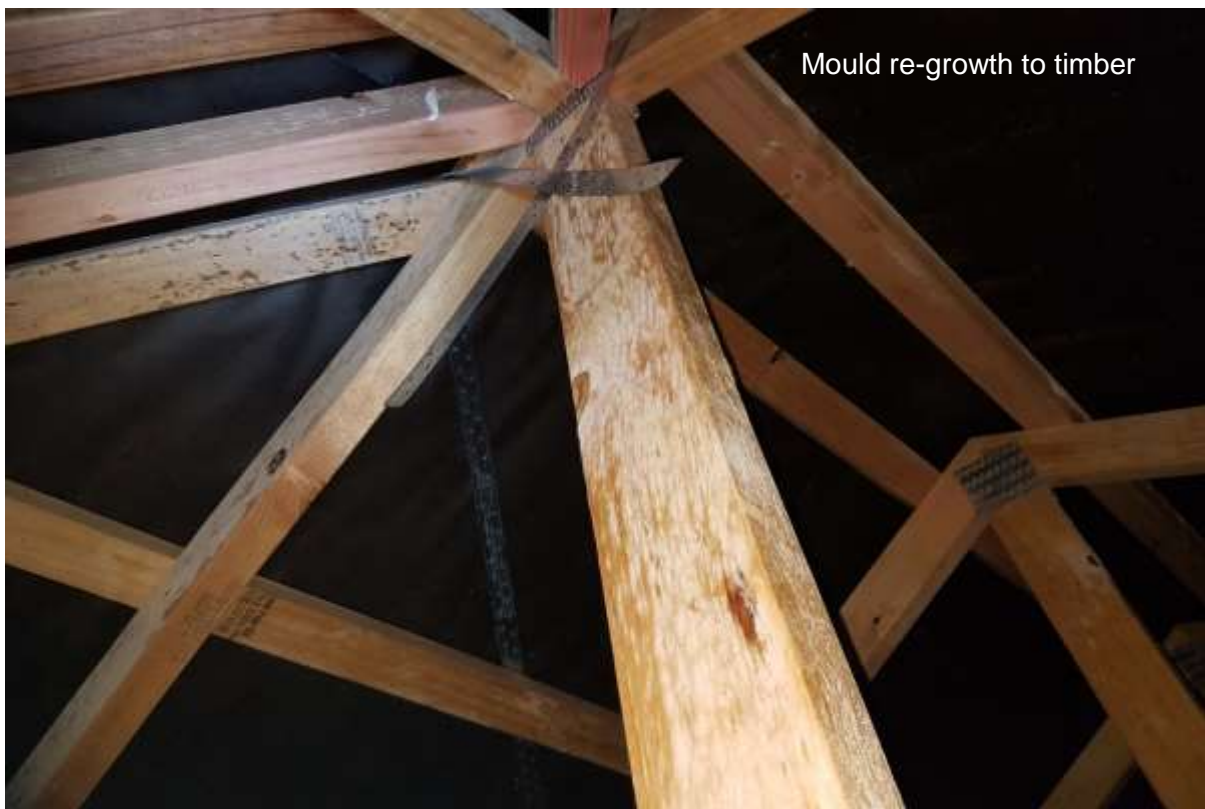
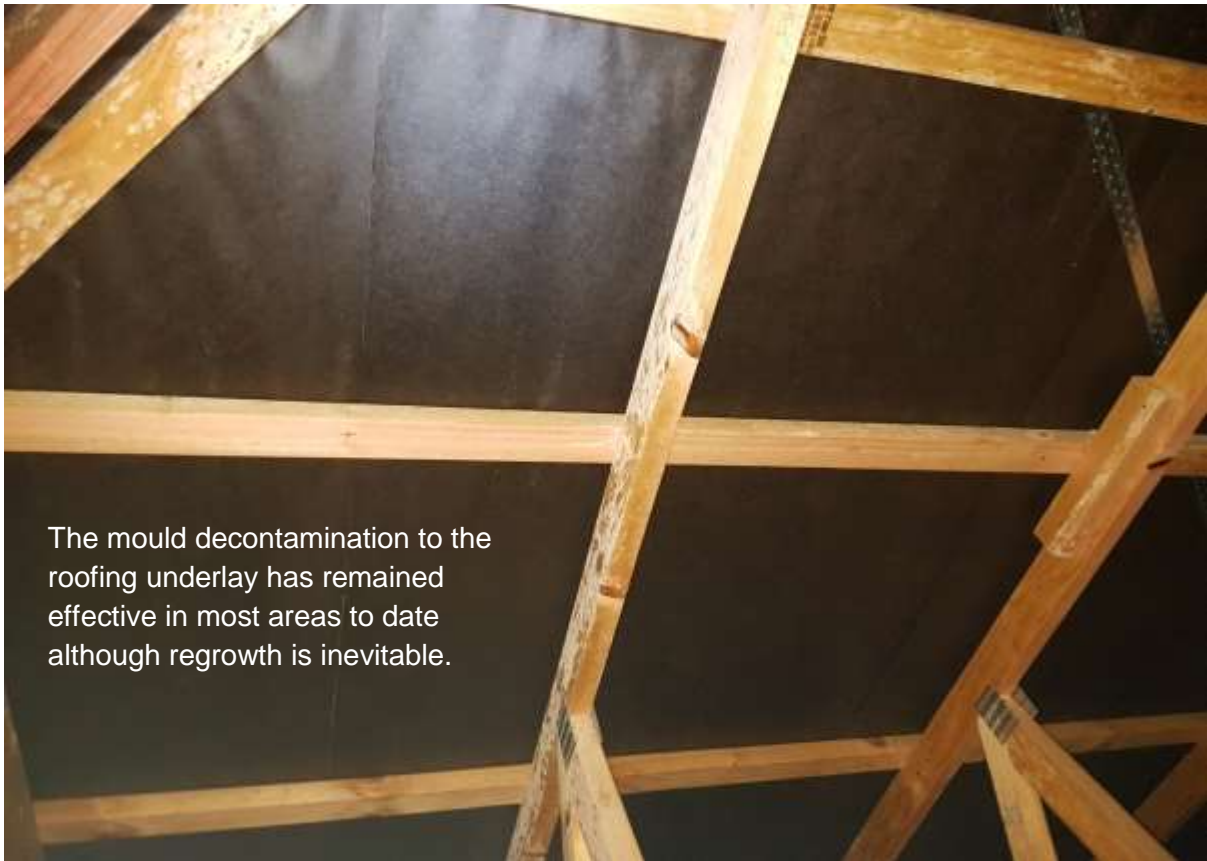
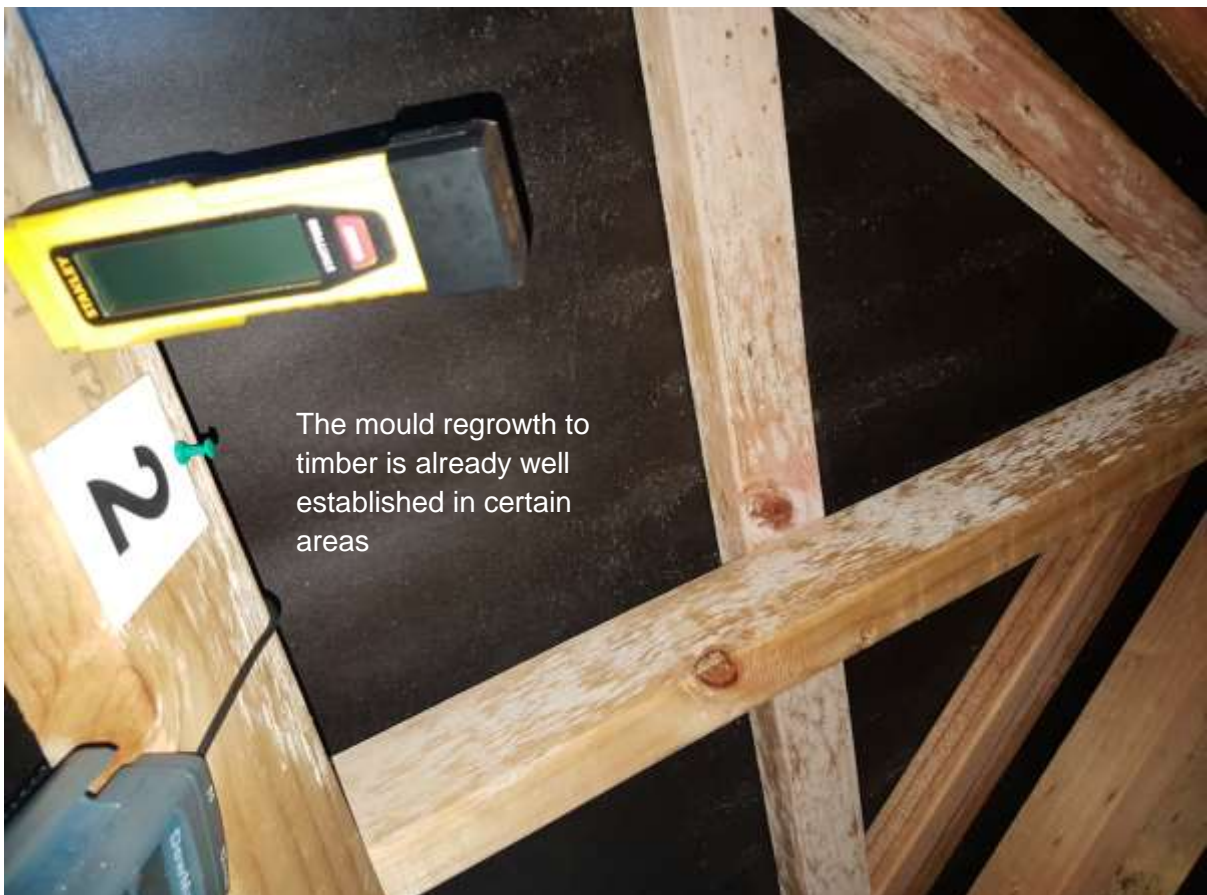
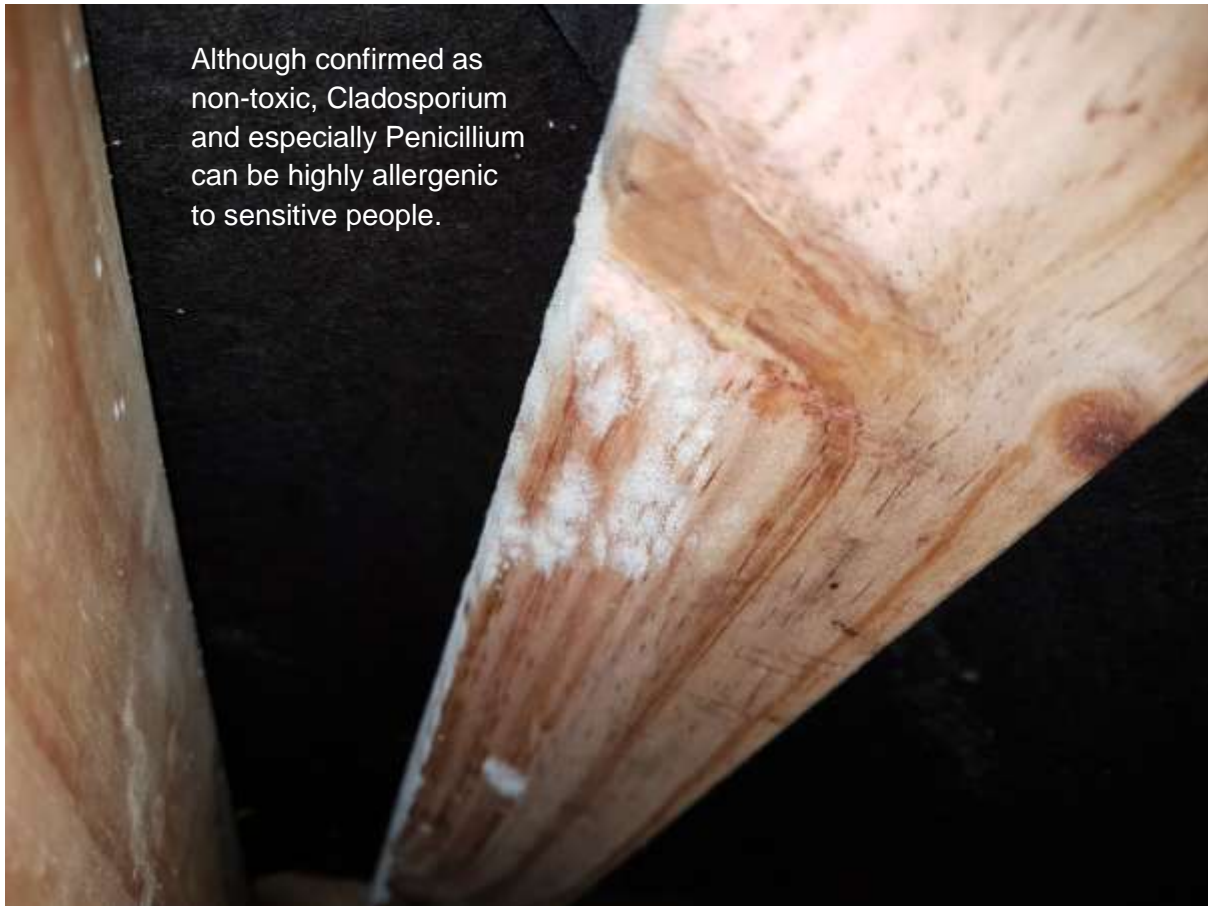
Additional Information and photos

Summary/Recommendation – From a health perspective, this property fortunately does not have a mechanical heating/ventilation system suspended in the roof void and the choice of lighting is LED making the roof void relatively sealed, safe and isolated from the living area. It would be advisable to provide a passive roof ventilation solution asap to reduce the moisture and humidity levels. When this is achieved, the mould can be decontaminated and should not return as it requires moisture to survive. The current mould growth is re-establishing too fast to warrant decontaminating at this time.

In this case I would recommend undertaking another Assessment Report in 4 weeks to test/monitor the temperature, relative humidity and moisture levels again. If the readings are reduced to an acceptable level, the mould can then be decontaminated with confidence.
