ASSESSOR REPORT

Client name:	Tel:
Site address:	Email:
Date: 11/10/17	Job Ref: TD/138

This was a non-invasive inspection undertaken on 10/10/17. The objective was to assess the regrowth of mould in the roof void. The mould on the roofing underlay and timber roof structure was chemically decontaminated on 28/09/17 as per photos provided at the time.

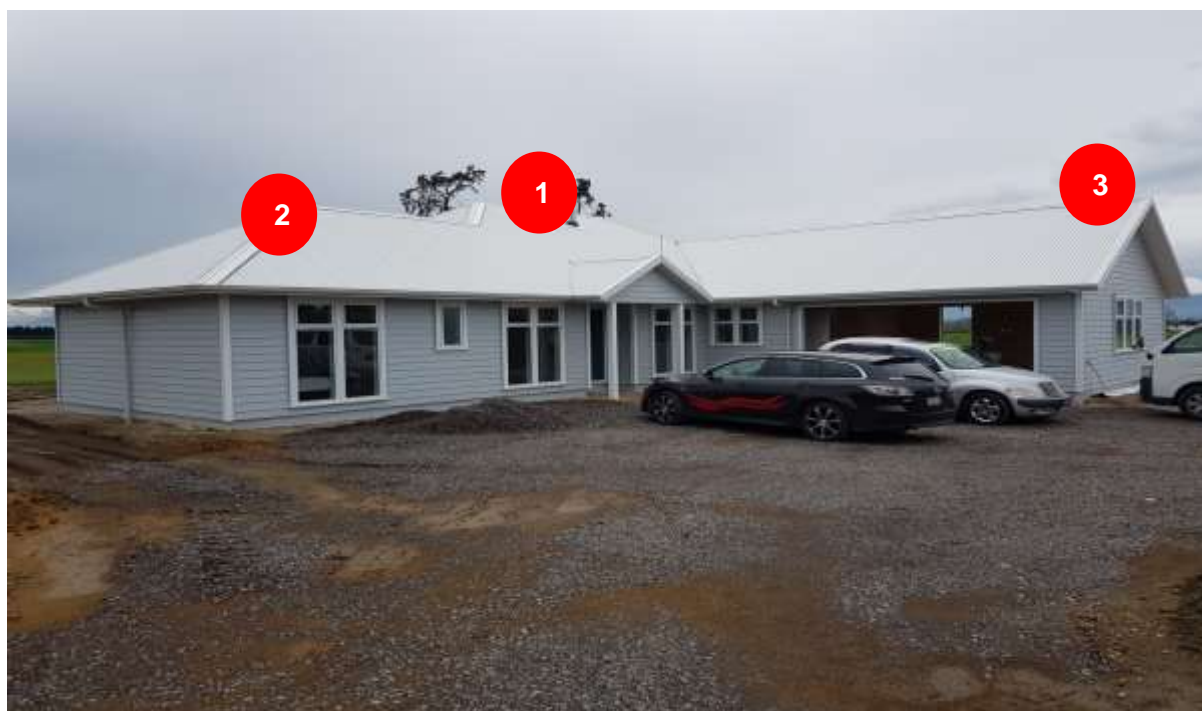
It was decided to test 3 areas at both ends and the highest point of the roof void for temperature, relative humidity and moisture content of the timber trusses.
